**Flood Control Project Maintenance  
Levee Inspections  
LMA District Cover Sheet  
Spring 2010 Levee Inspection Results**

**Levee District No. 0003 (Glenn County)**

**Levee Inspection Report By Mile - Spring 2010**

Waterway							Bank	Unit Miles	Inspection Start/End	Inspector
Unit No. 01 Glenn County Sacramento River							Left	12.24	05/26/2010 05/26/2010	Bob Duffey
LMR No.	Levee Mile		Category	Item	Location	Rating	Action/Comment	GPS Latitude/Longitude		Issue No.
	Start	End						Start	End	Photo
1	0.56	0.63	Earthen Levee	Animal Control	LS	M	No rodents visible, but rodent burrows visible; need to backfill and compact or grout borrows.	39.389390 ° -121.995539 °	39.389219 ° -121.996854 °	23
2	0.75	0.75	Earthen Levee	Animal Control	LS	M	No rodents visible, but rodent burrows visible; need to backfill and compact or grout borrows.	39.388323 ° -121.998727 °	39.388323 ° -121.998727 °	3
3	1.22	1.28	Earthen Levee	Animal Control	LS	M	No rodents visible, but rodent burrows visible; need to backfill and compact or grout borrows.	39.394070 ° -122.001016 °	39.394918 ° -122.001114 °	24
4	1.41	1.61	Supplemental	USACE Erosion Survey	WS	U	Inspector Comments: 2009: 15 ft berm, 1:1 slope, tree haz

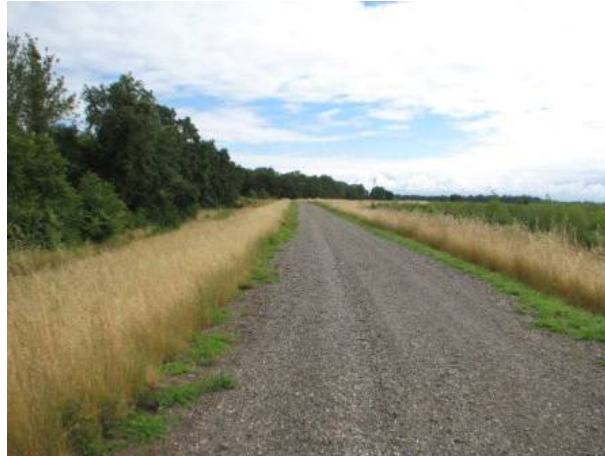
Levee Mile Report Line	4
Start Levee Mile	1.41
End Levee Mile	1.61
Location	Water Side
Category	Supplemental
Item	USACE Erosion Survey

Typical view of the grasses on the Levee.

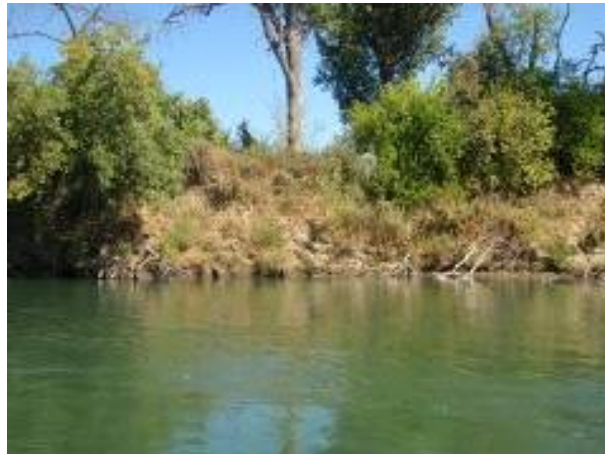
Levee Mile Report Line	4
Start Levee Mile	1.41
End Levee Mile	1.61
Location	Water Side
Category	Supplemental
Item	USACE Erosion Survey

2009: 15 ft berm, 1:1 slope, tree hazards and slumping, clays and silts, 10.07 ft/s [2009 SiteID:SAC\_163-0\_L]

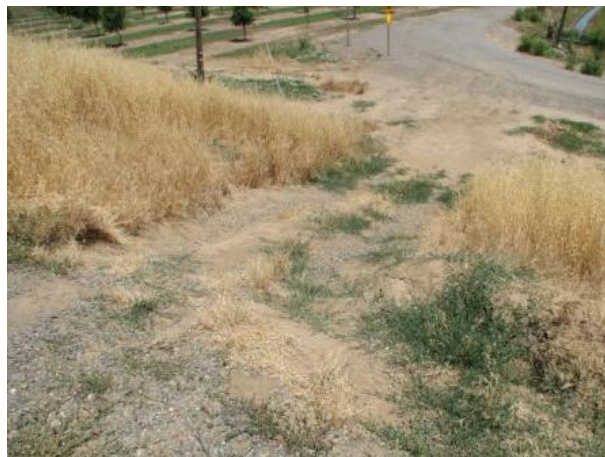
Levee Mile Report Line	5
Start Levee Mile	3.44
End Levee Mile	3.44
Location	Land Side
Category	Earthen Levee
Item	Slope Stability

View of the vehicle erosion on the landside slope of the levee.

5	3.44	3.44	Earthen Levee	Slope Stability	LS	M	Repair the levee slope damaged by vehicle traffic and prevent access where possible.	39.418267 ° -121.992472 °	39.418267 ° -121.992472 °	9 Y
6	3.68	3.68	Earthen Levee	Animal Control	LS	M	Exterminate rodents and backfill and compact or grout burrows.	39.421735 ° -121.992097 °	39.421735 ° -121.992097 °	1
7	5.17	5.30	Earthen Levee	Trim / Thin Trees	LS	M	Trim trees to at least five feet above ground level.	39.441448 ° -121.990597 °	39.443140 ° -121.990965 °	2
8	5.21	5.21	Earthen Levee	Animal Control	LS	C	No rodents visible, but rodent burrows visible; need to backfill and compact or grout borrows.	39.441947 ° -121.990702 °	39.441947 ° -121.990702 °	41
9	6.88	6.88	Earthen Levee	Trim / Thin Trees	LS	M	Trim trees to at least five feet above ground level.	39.465013 ° -121.991455 °	39.465013 ° -121.991455 °	35 Y
10	7.34	7.34	Earthen Levee	Slope Stability	LS	M	Repair the levee slope damaged by vehicle traffic and prevent access where possible.	39.471658 ° -121.991245 °	39.471658 ° -121.991245 °	14

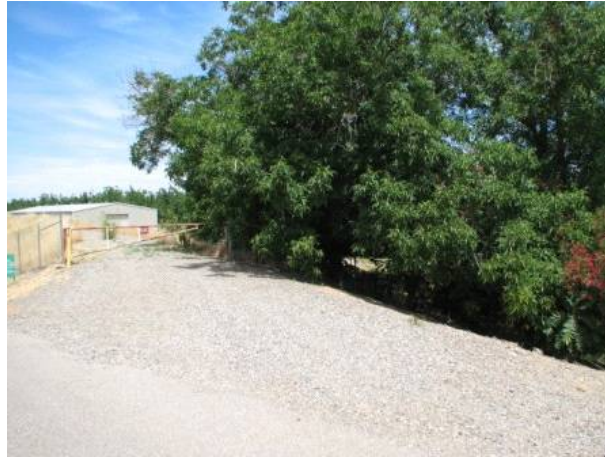
Levee Mile Report Line	9
Start Levee Mile	6.88
End Levee Mile	6.88
Location	Land Side
Category	Earthen Levee
Item	Trim / Thin Trees

View of the trees that are hanging over the landside slope of the levee.
